CIVIL AERONAUTICS BOARD

ACCIDENT INVESTIGATION REPORT

NORTHWEST AIRLINES, INC.—MT. SANFORD, ALASKA—MARCH 12, 1948

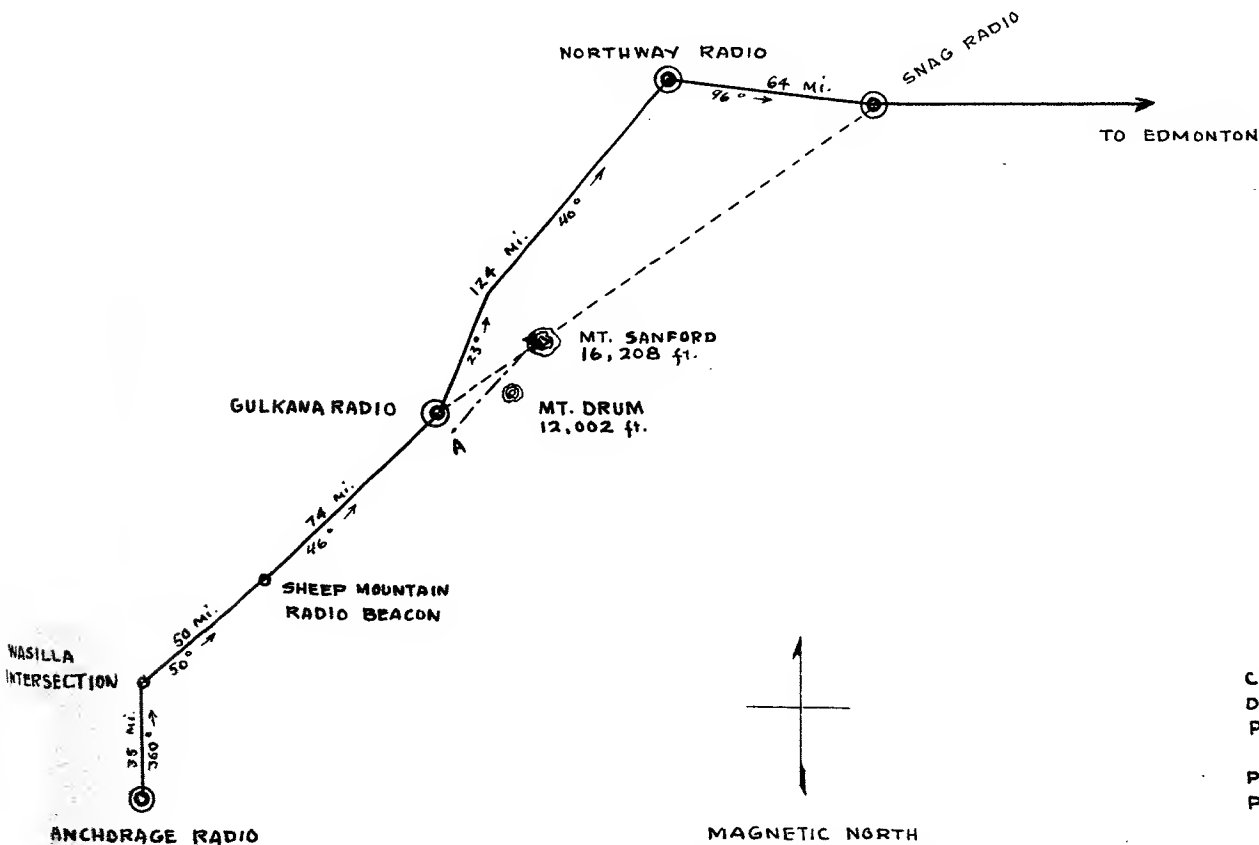
CHART OF AIRWAY FROM ANCHORAGE TO SNAG

Since the aircraft was observed to fly easterly from Gulkana, at which time it was 4 miles south of the Gulkana radio range station, it appears that the flight was not following the airway, but was flying directly from Gulkana to Snag. It is probable that the pilot, relying on good visibility, felt confident that he would see Mt. Sanford and be able to safely circumnavigate it. Though no clouds were reported, the top of Mt. Sanford could very well have been capped by a thin layer of clouds. Such a layer of clouds would not only have tended to obscure the mountain but may have acted as a reflector for the aurora borealis which was observed to be particularly brilliant the night of this flight.

8. The aircraft crashed approximately 42 miles 51 degrees from the Gulkana radio range station on Mt. Sanford at its cruising altitude of 11,000 feet, and 23 miles southeast of the center line of the airway as described above.
